Date: 03/10/11
To: Minerals File UTU-68061
From: Ted McDougall, Geologist
Subject: Surface Management Site Inspection, Denison Mines, Rim/Columbus Mine, UTU-68061 (M037/006), West Summit, San Juan County, Utah.

Date of Inspection: 03/09/11
Time of Inspection: 11:00 A.M.
Participants: Ted McDougall
Legal Description: T. 31 S., R. 25 E., Section 29 and 30
Mining Claims Involved: Humbug, Poor Boy, and Columbus Groups
Claimant/Operator: Denison Mines Corp.

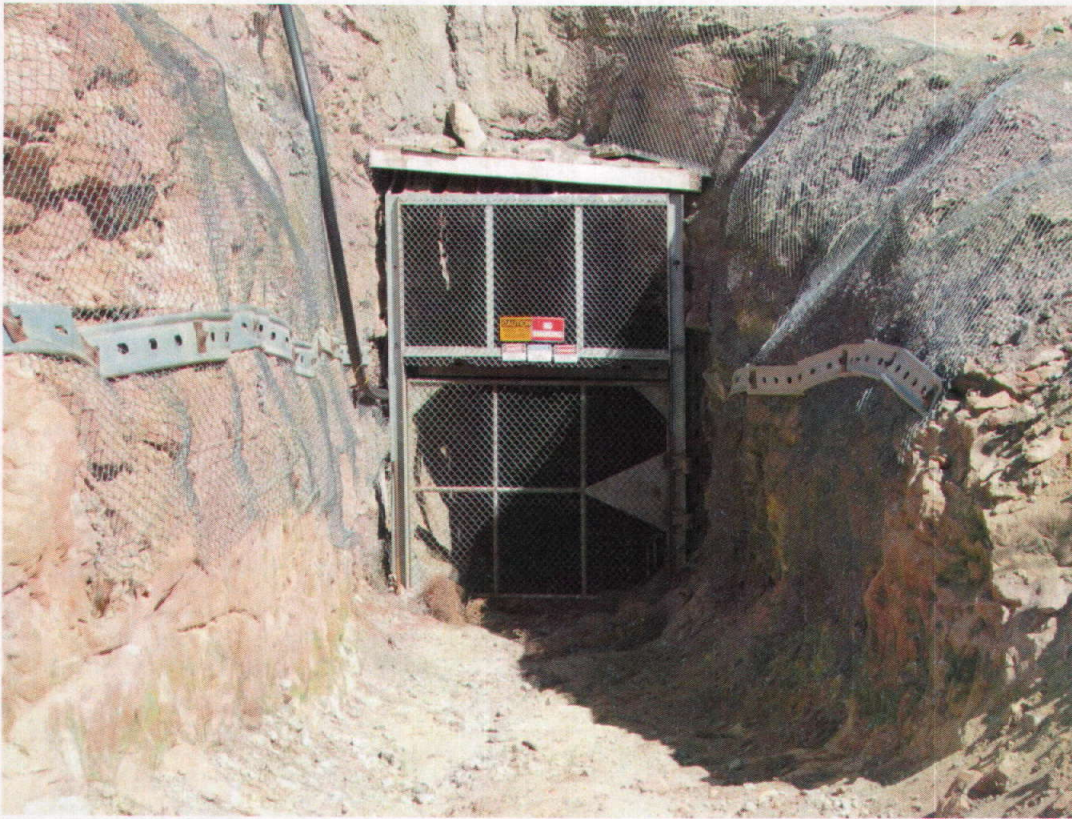
The gate at the portal is secure and the work areas around the Rim Shaft and Humbug Portal/Shop area have been cleaned up.

Humbug Portal/Shop Area
